Navajo Abandoned Uranium Mine

Site Screen Report

Ramco No. 21 AUM Site

January 2011

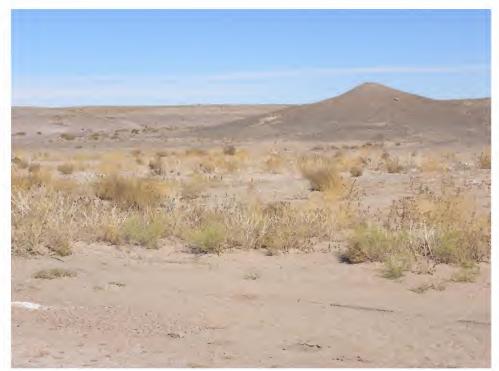
Photo 1. Ramco No. 21 mine site

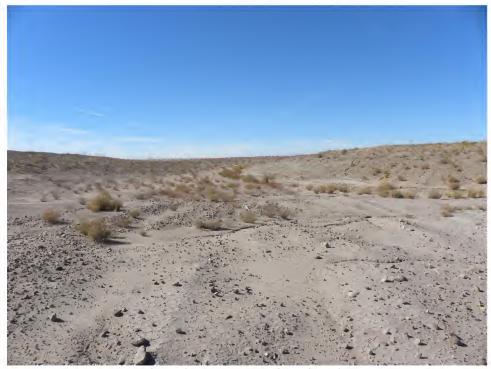
Photo 2. Ramco No. 21 mine site

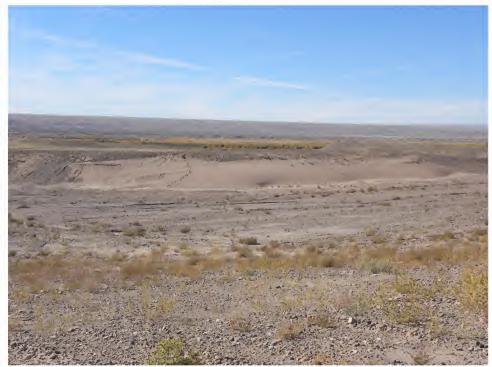
Photo 3. Ramco No. 21 mine site

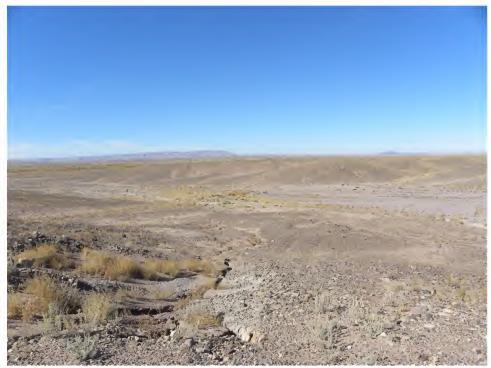
Photo 4. Ramco No. 21 mine site drainage

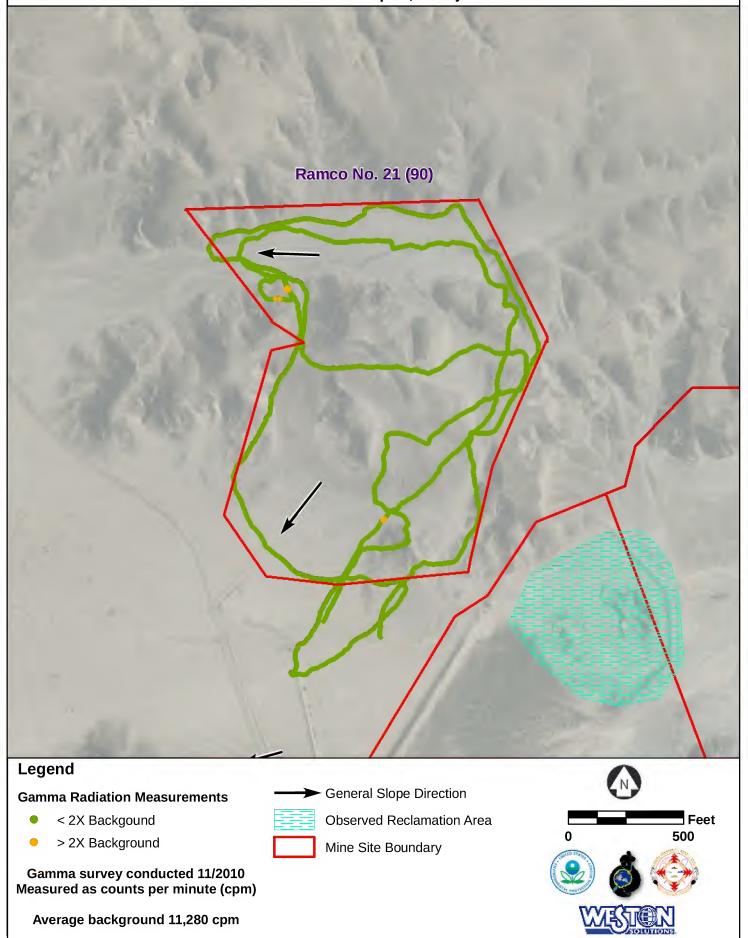
Highest gamma radiation measurement:

74,778 counts per minute (cpm)

A total of 4,312 gamma radiation measurements were collected from the mine site, ranging from 9,037 cpm to 74,778 cpm. The measurements are represented in Figures 1 and 2.

Figure 1 - Gamma Radiation Measurements, Above Two Times Background
Ramco No. 21 (90)
Coalmine Mesa Chapter, Navajo Nation

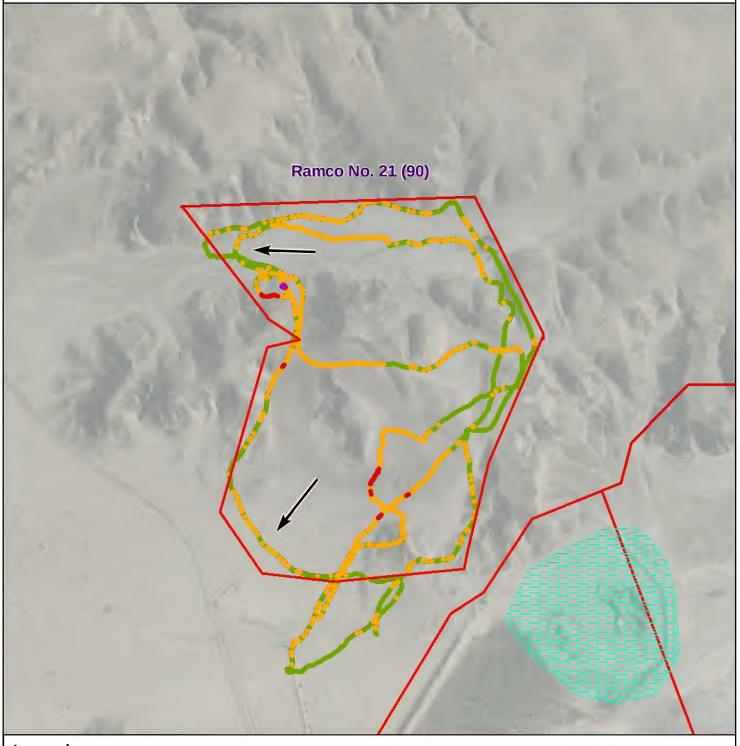
Figure 2 - Gamma Radiation Measurements Ramco No. 21 (90) Coalmine Mesa Chapter, Navajo Nation
